S799 Servo Bore Repair System:
Torque Flight Detent

This tool is for use on **Chrysler Torque Flight (72-08, Big and Small)** transmissions.

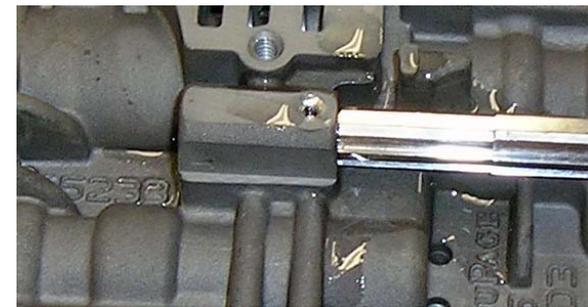
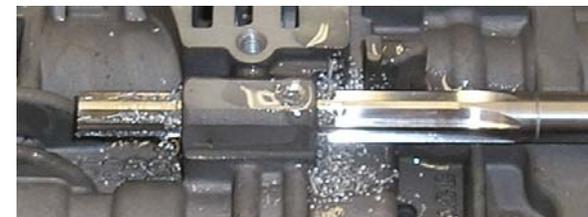
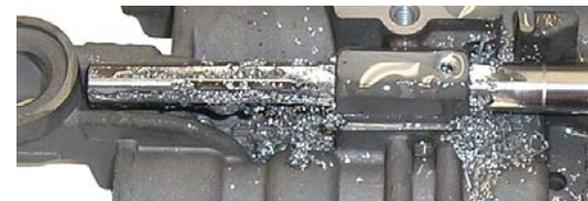
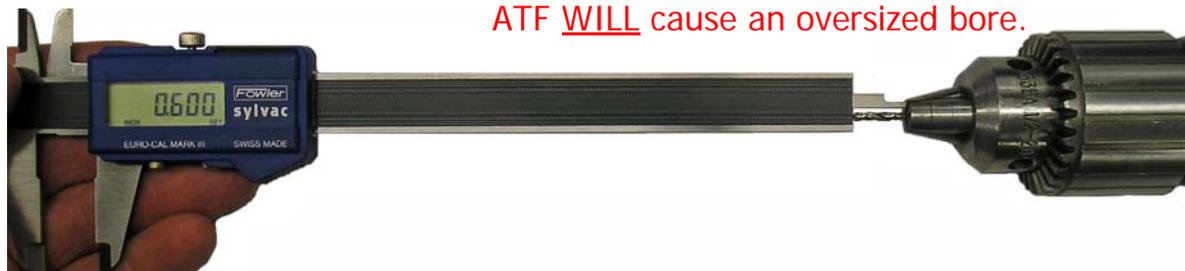
7. Drill spring stop pin hole. Use provided .093" drill. Take care not to drill the casting when you pass through the bottom of the bushing. As a safety precaution, set your bit deeper in the chuck. At .600" you will safely drill only the sleeve on all valve bodies.

8. Drive included gauge pin through the bushing. Check to make sure that the ball is free in the end of the sleeve.

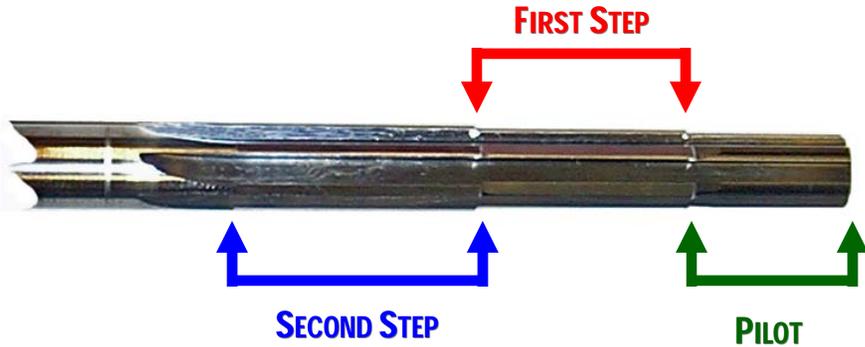
Reamer Explanation

This kit only uses one reamer. The reamer has three sections. Each section serves as a pilot for the one behind it.

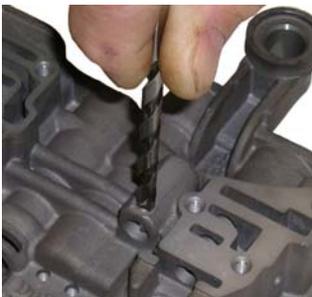
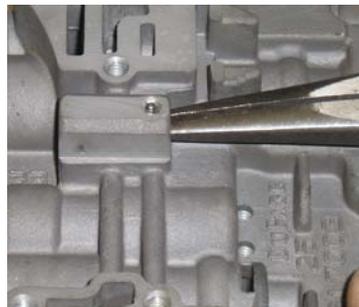
Spring Stop Pin Removal

In a word, removing the spring stop pin can be a pain. What we've found to be the easiest way, is to use the web of a 1/4" drill bit to sort of counter-bore the staking around the top of the pin. Once this has been accomplished, a needle-nose pliers is used to work the pin up and down. Work the pin until enough of it protrudes from the casting to pull the pin directly out.

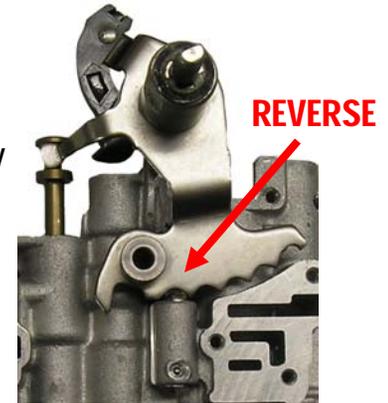
1. Install the manual linkage parts (valve, rooster comb, ball, and spring) on the valve body. You may want to install the T.V. plunger to hold the linkage together while checking adjustment. Place the linkage in reverse.

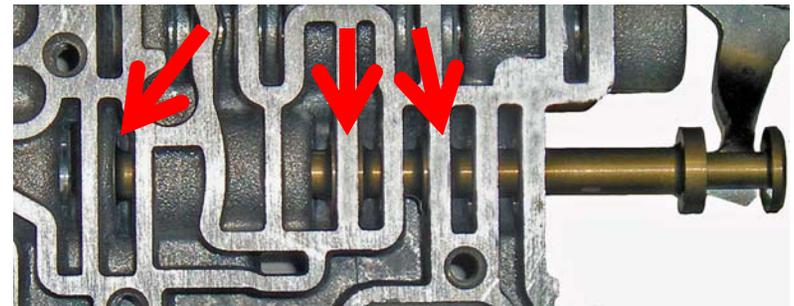
Valve Lands

2. Flip the valve body over and inspect the manual valve. The valve lands should look like the above picture. Adjustments can be made with a 3/8" fitting wrench.

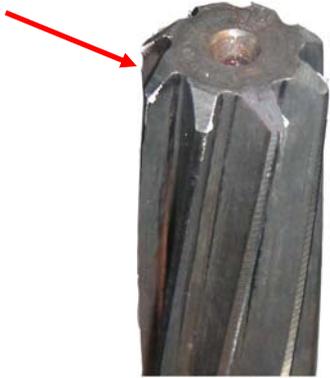
Important Reamer Info

Inspect for aluminum buildups on the cutting edges as pictured left.

Reamers are like drills, if you use them repeatedly in aluminum they develop build-ups on the cutting edges. These build-ups effectively make the reamer larger, causing a larger hole. This causes the valve to be loose in the bore, which defeats the entire purpose. To prevent this, you need to (1) keep your reamers sharp and (2) use plenty of CUTTING OIL when reaming.

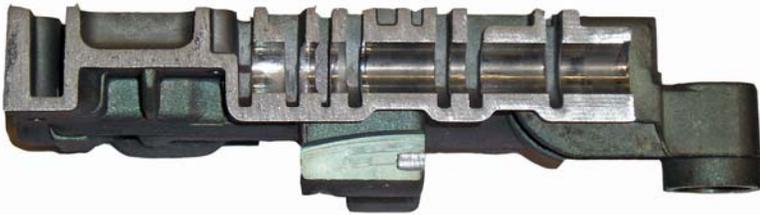
Check the Throttle Valve...

Torque Flights tend to wear out the throttle valve bore. Check out our TFTV kit to repair this in Torque Flights, 48RE's, and 31TE's.
