S799 Servo Bore Repair System:

4T60-R

This tool is for use on **GM 4T60E** and **4T65E** transmissions.

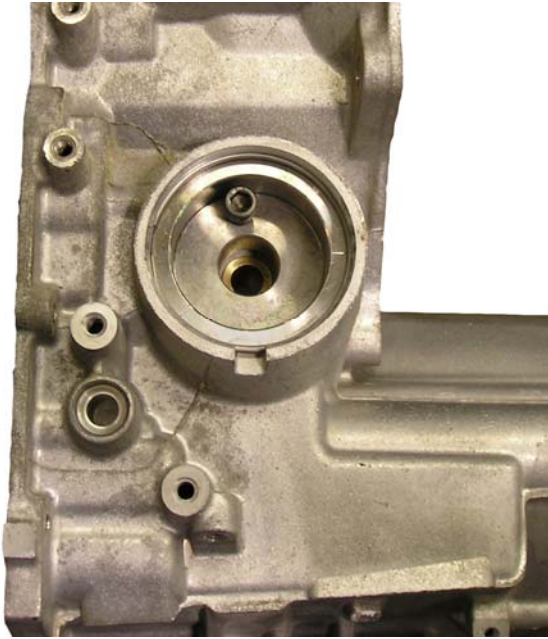
1. Install the drill jig into the case by setting the jig into the servo. Retain the jig in the case with the servo's snap-ring.
2. Drop the 5/8" guide into the jig. It doesn't matter which one of the lands on the guide you use, as long as one of the lands is under the 3/8" Allen screw.
3. Ream out the bore using the 5/8" reamer, applying ample lubrication.* **DO NOT REAM ABOVE 500 RPM.**
4. Replace the 5/8" reamer guide with the 11/16" guide, and the 5/8" reamer with the 11/16" reamer.
5. Ream the bore out using the 11/16" reamer with ample lubrication.* Take care not to either push too hard on the reamer or turn the reamer faster than 500 RPM when reaming. Either one can overly enlarge the bore, causing a loose bushing.
6. Clean the case before proceeding to step number seven.
