**BLUE
SERIES**

S799 Servo Bore Repair System:

F4

This tool is for use on **Ford 4EAT-F (F4A-EL)** transaxles.

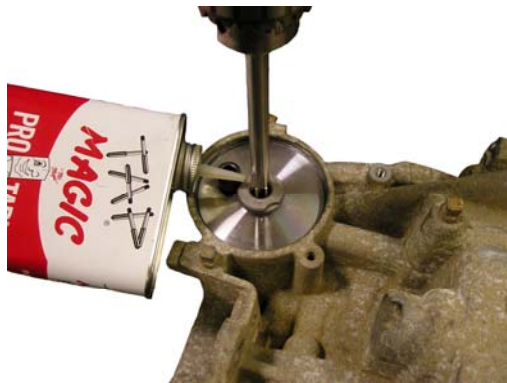
7. Apply Loctite® (preferably **green #680**) or equivalent to the bushings and drive the bushings in by hitting the driver until the bushing bottoms.
8. Insert the provided sizing pin into the bore, chamfer first. It may be necessary to start the pin in the bushing with a rubber mallet. Once the pin is inside the bushing, use a punch to drive the pin all the way through the bushing. Repeat as necessary.

*- **CUTTING OIL** must be used for lubrication. The use of substitutes, particularly ATF, may result in an over-sized bore.

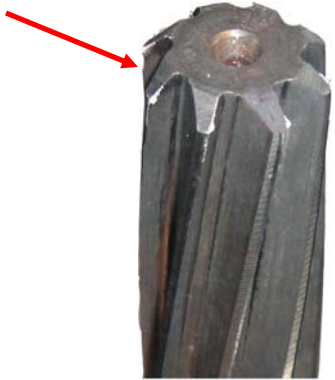
Inspect for aluminum buildups on the cutting edges as pictured left.

Reamers are like drills, if you use them repeatedly in aluminum they develop build-ups on the cutting edges. These build-ups effectively make the reamer larger, causing a larger hole. This larger hole then robs the bushing you're installing of interference needed to properly crush the bushing. This causes the pin to be loose in the bushing, which defeats the entire purpose. To prevent this, you need to (1) keep your reamers sharp and (2) use plenty of CUTTING OIL when reaming.
